INFRARED THERMAL IMAGING NOVEMBER 2011

Amcoat Industries, Inc completed a thermal imaging study in 2011. A wall was constructed consistent with Florida building codes. The exterior cladding was cement board siding. Half of the wall was coated with a grey latex paint; the other with Rhino Shield in a matching grey color.

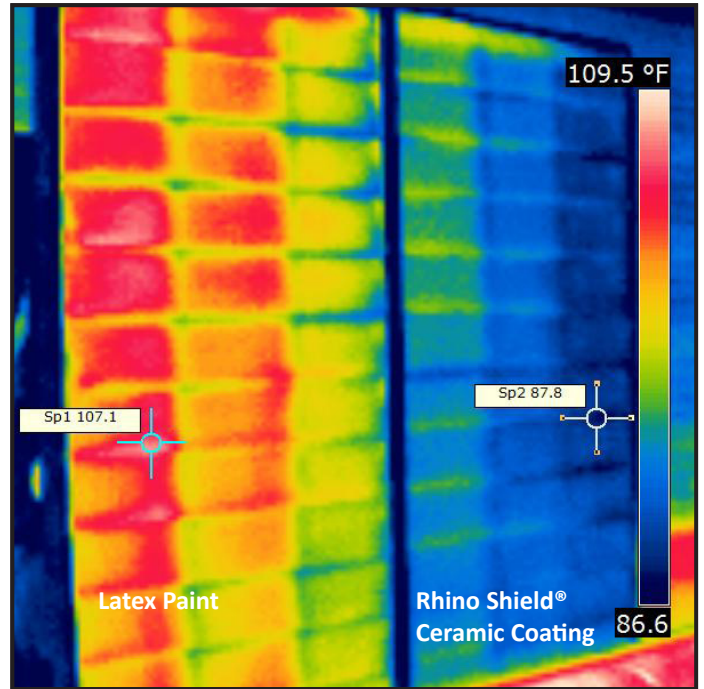
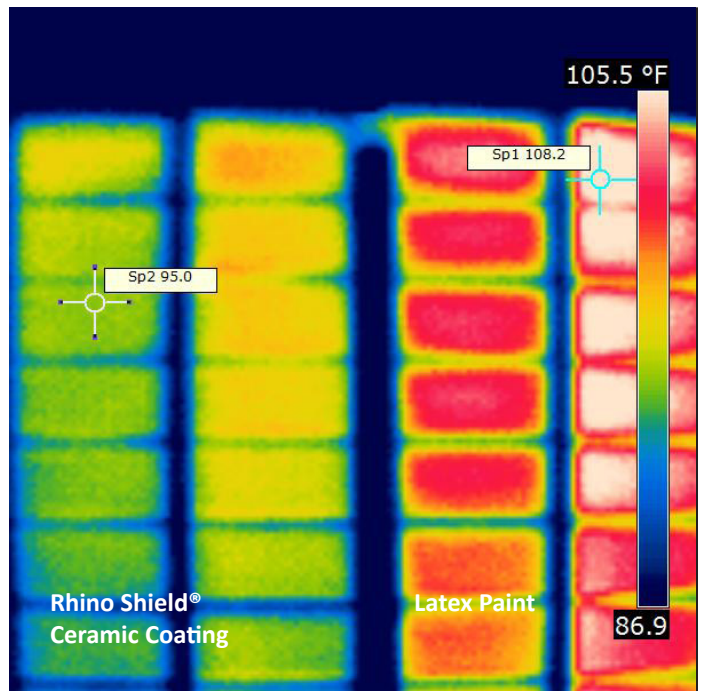
The second set of images were taken on a roofing system with an enclosed attic space. The roof structure was built to Florida code and utilized asphalt shingles. Half of the shingle roof was coated with Rhino Shield Super Shield Ceramic Roof Coating; the other half remained bare shingles. The images were taken in early November 2011 in North Florida.

Both structures were exposed to 75°F (24°C). Testing is scheduled to be repeated in hotter weather in 2012.

The weather conditions at the time of the test were sunny and clear with a temperature of 75 degrees Fahrenheit. The results as indicated by the attached radiometric photos show a significantly lower temperature on the backside (interior) of the wall. The coating appears to keep the wall structure cooler and reduces the amount of thermal energy that passes through the wall. It is my conclusion that the lower temperatures would make a notable difference to the cost of cooling a building. These results should prove even more drastic in warmer climates with higher daytime temperatures. Please feel free to contact me with any questions that you may have regarding my finding or credentials.
